# The significance of extreme floods in the transformation of mountain valleys and causing flood risk, on the example of the July 2001 flood that occurred in the upper catchment of the river Skawa

Paweł Franczak\*

*University of Applied Sciences in Tarnow, Faculty of Mathematical and Natural Sciences, ul. Mickiewicza 8, 33-100 Tarnów, Poland*

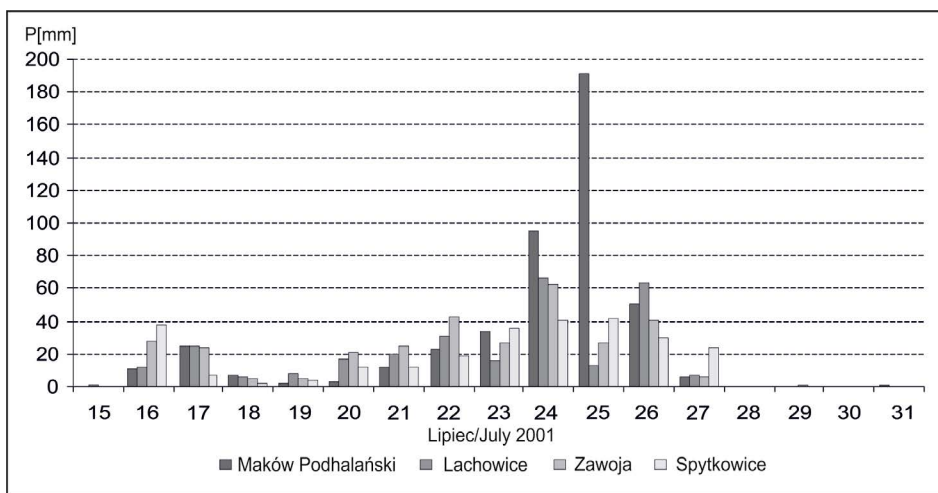
Figure 2. Daily precipitation on 15-31 July 2001 in the study area

On 24 July, in the source part of the Skawa, the rainfall amounted (35–40 mm), whereas in its other parts it reached much higher values, from 61.9 mm in Zawoja to 94.6 mm in Maków Podhalański. On the next day (25 July), the rainfall in most parts of the catchment amounted from 12.4 mm in Lachowice to 41.8 mm in its source fragment. However, its central part has been subject to a catastrophic showering rain reaching up to 190.8 mm in Maków Podhalański [30, 31, 44, 46]. The most extensive rainfall from the atmospheric centre located above Makowska Góra was observed between 3:00 and 6:00 p.m. – circa 150 mm [47]. In the station in Bogdanówka, situated at the edge of the centre (7 km to the east), the 24-hour sum of rainfall was 68.7 mm. The next few days the rainfall continued, reaching 64 mm the very next day, lasting until 28 July (Fig. 2).

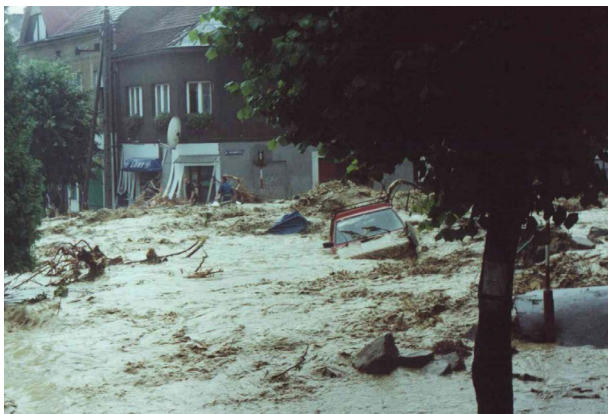
**Figure 4.** Maków Podhalański during the flood in 2001

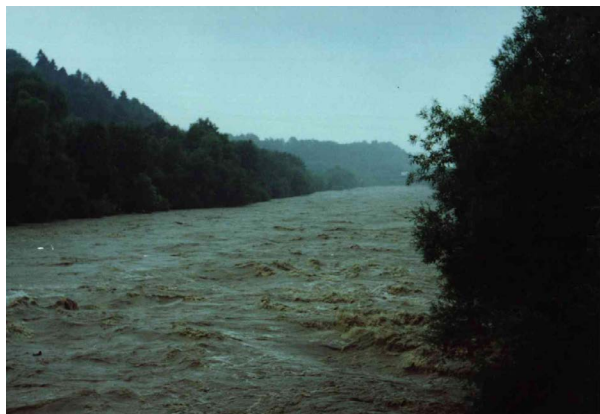
**Figure 5.** The Skawa River in Maków Podhalański during the flood in 2001

On the other hand, for the Skawa in Sucha Beskidzka, this coefficient was  $1574 \text{ dm}^3/\text{s}/\text{km}^2$  (Fig. 5). These two water gauge profiles also had one of the highest K flood indices, which amounted to  $4.13$  in Osielec and  $4.12$  in Sucha Beskidzka. According to P. Jokił's and P. Tomalski's [42] calculations, the Łopuszanka in Piaski had the highest value of the K index ( $4.64$ ). However, in Poland as a whole, only in less than 10% of cases the calculated K indices were higher than  $3.5$ , and those exceeding  $4.0$  were rare and calculated mainly for the Carpathian rivers. Higher unit runoff coefficients and K flood indices were recorded only for very small, uncontrolled mountain catchments [26, 33].

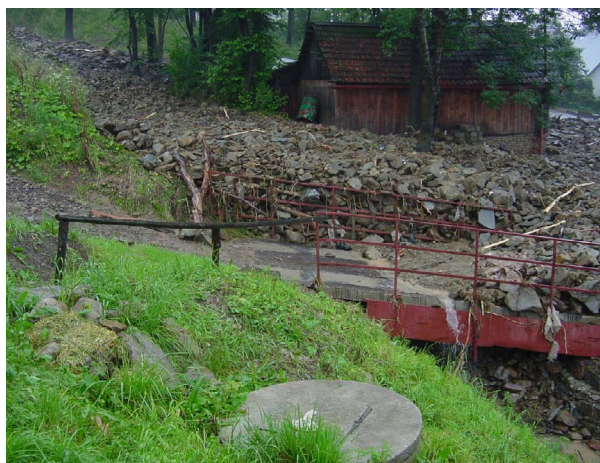
**Figure 6.** Alluvial fans in the Księży Potok catchment

In the upper Skawa catchment area, the greatest geomorphological transformations occurred in the Paleczka catchment area and on several short right-bank tributaries of the Skawa flowing into it between Maków Podhalański and Sucha Beskidzka. Numerous fresh erosive undercuts and sandbanks up to 50 m<sup>2</sup> in size were created within these watercourses. The largest transformations took place in the river bed of the regulated Księży Potok flowing in its lower section through the centre of Maków Podhalański. Within the narrow valley bottom, the concrete and stone retaining walls protecting the shore and the communication routes leading alongside it, from which the material was accumulated below, were destroyed. Numerous erosive undercut up to 5 m high was formed, and erosion gutters up to 20 m long and 1 m deep were created within the valley bottom. Waterfall thresholds ranging in height from 0.5 to 1.5 m have formed in the longitudinal profile of the bed on the shoals of Magura sandstones. Meanwhile, in the lower sections of streams flowing down the Makowska Góra in sections with a smaller longitudinal decrease and in the areas of rapid change in the direction of the river bed (transformed by humans), wide alluvial fans with an area of up to 5100 m<sup>2</sup> were formed (Fig. 6).
